SENENICH PROPELLER MANUFACTURING COMPANY, INC.

Service Memo C08-1D

Hub clamp bolt replacement for the 2EK series Composite propeller retention system. Lowering the time between clamp bolt replacements to **10 hours**.

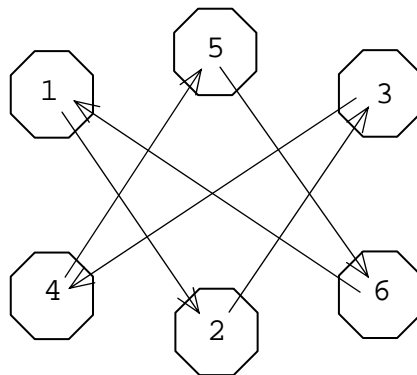
Recent incidents of hub clamp bolt failures used to secure the propeller hub halves have prompted Sensenich Propeller Mfg. Company Inc. to issue a service memo to replace and torque to 28-30 Ft-lb. the (6)-AN6-15A clamp bolts every **10 hours** of operation. Please call (717-569-0435) or email (sales@sensenich.com) the Sensenich Propeller Mfg. Company Inc. for replacement bolts at no cost.

Using a calibrated torque wrench and following the pattern shown below. Tighten the bolts in $\frac{1}{4}$ to $\frac{1}{2}$ turn increments (this will take several passes) until the proper torque given in **Table 1** is reached. It is important to maintain an even gap between the hub halves.
